DEPARTMENT OF TRANSPORTATION**DIVISION OF ENGINEERING SERVICES**

Contract #: 04-0120F4Cty: SF/ALA Rte: 80 PM: 13.2/13.9File #: 1.28**WELDING INSPECTION REPORT****Resident Engineer:** Casey, William**Address:** 333 Burma Road**City:** Oakland, CA 94607**Report No:** WIR-027965**Date Inspected:** 15-Jul-2012**Project Name:** SAS Superstructure**OSM Arrival Time:** 700**Prime Contractor:** American Bridge/Fluor Enterprises, a JV**OSM Departure Time:** 1530**Contractor:** American Bridge/Fluor Enterprises, a JV**Location:** Job Site**CWI Name:** William Sherwood**CWI Present:** Yes No**Inspected CWI report:** Yes No N/A**Rod Oven in Use:** Yes No N/A**Electrode to specification:** Yes No N/A**Weld Procedures Followed:** Yes No N/A**Qualified Welders:** Yes No N/A**Verified Joint Fit-up:** Yes No N/A**Approved Drawings:** Yes No N/A**Approved WPS:** Yes No N/A**Delayed / Cancelled:** Yes No N/A**Bridge No:** 34-0006**Component:** SAS Tower**Summary of Items Observed:**

WELDING INSPECTION REPORT

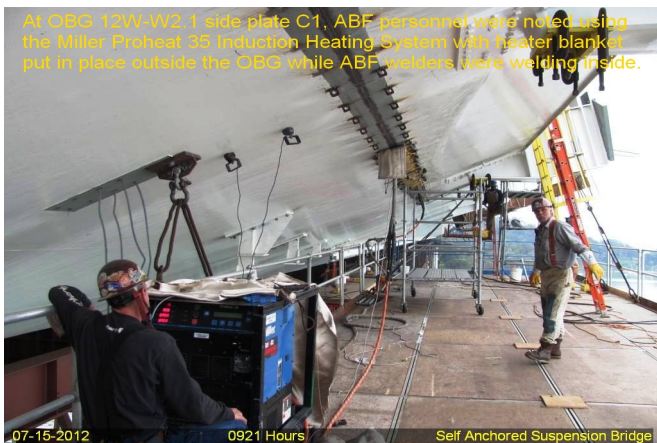
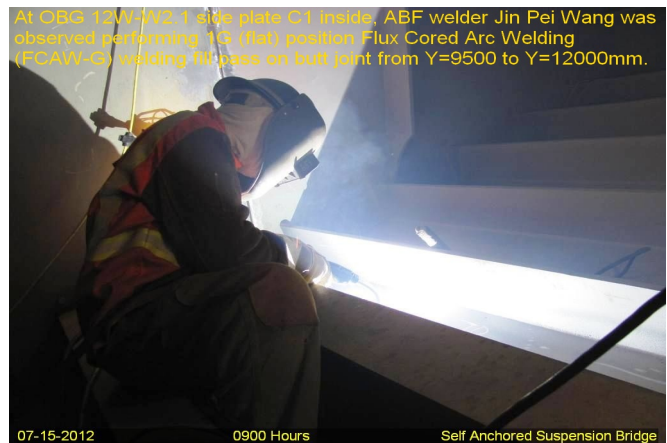
At OBG 12W-W2.1-C1 inside, QA randomly observed ABF/JV qualified welder Jin Pei Wang perform fill pass to cover pass welding on the Complete Joint Penetration (CJP) splice butt joint. The welder was observed manually welding in the 1G (flat) position utilizing a Flux Cored Arc Welding (FCAW-G) with E71T-1M, 1/16" diameter wire electrode and implementing Caltrans approved Welding Procedure Specification (WPS)

ABF-WPS-D15-3040A-1. The joint being welded has a single V-groove butt joint with backing bar that will be removed and back gouged. The plates were preheated and maintained to required temperature of 200°F using Miller Proheat 35 Induction Heating System with the heater blanket put in place at the other side of the joint being welded. During welding, ABF Quality Control (QC) William Sherwood was noted monitoring the welding parameters of the welder with measured working current of 255 amperes and voltage of 23.5 volts. During the shift, cover pass FCAW-G welding at weld joint mentioned above from Y=9500mm to 12000mm was completed and the welded joint deemed satisfactory. The welder held the same preheat of 200°F for three (3) hours after welding as required.

At OBG 12W-W2.1-C1 inside, QA randomly observed ABF/JV qualified welder Xiao Jian Wan perform fill pass to cover pass welding on the Complete Joint Penetration (CJP) splice butt joint. The welder was observed manually welding in the 1G (flat) position utilizing a Flux Cored Arc Welding (FCAW-G) with E71T-1M, 1/16" diameter wire electrode and implementing Caltrans approved Welding Procedure Specification (WPS)

ABF-WPS-D15-3040A-1. The joint being welded has a single V-groove butt joint with backing bar that will be removed and back gouged. The plates were preheated and maintained to required temperature of 200°F using Miller Proheat 35 Induction Heating System with the heater blanket put in place at the other side of the joint being welded. During welding, ABF Quality Control (QC) William Sherwood was noted monitoring the welding parameters of the welder with measured working current of 285 amperes and voltage of 23.0 volts. During the shift, cover pass FCAW-G welding at weld joint mentioned above from Y=7000mm to 9500mm was completed and the welded joint deemed satisfactory. The welder held the same preheat of 200°F for three (3) hours after welding as required.

At the request of Quality Control Field Supervisor, Bonifacio Daquinag, QA has randomly verified the QC VT/MT of the following various welded joints. The QA verification was performed to verify that the welding and the VT/MT inspection performed by the QC inspector meet the requirements of the contract documents. At the conclusion of the QA verification it appeared that the weld and the QC inspection complied with the contract documents.

1. 13E-PP123.5-E2.1 BW1 – floor beam web splice butt weld joint QA verified.
2. 13E-PP123.5-E2.1 BF1 – floor beam flange splice butt weld joint QA verified.
3. 13E-PP124-E2.2 BW1 – floor beam web splice butt weld joint QA verified.
4. 13E-PP124.5-E2.2 BW1 – floor beam web splice butt weld joint QA verified.
5. 13E/14E-LS7 – longitudinal stiffener splice butt weld joint QA verified.
